REPORT NO. 96-22

WOODEN PALLET FOR PA116 CONTAINERS MIL-STD-1660 TESTS

U.S. Army Armament Research, Development and Engineering Center
ATTN: AMSTA-AR-ESK

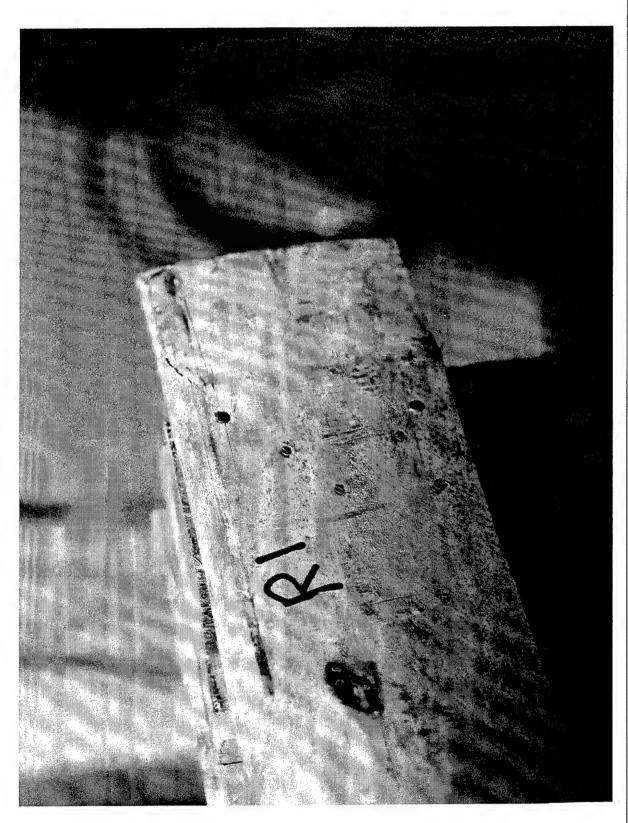
AO317-SCN96-140-2701. This photo shows the nails fastening a skid to the post of a reworked pallet. Note the additional number of nails used.

Olin Ordnance added two additional nails fastening the skid to each post. The additional nails are described in D on page 5-1.
